NRL/MR/6110--99-8399

FIELD TOUR OF UXO ACTIVITIES ON THE FORMER NAF ADAK

23 June 1999

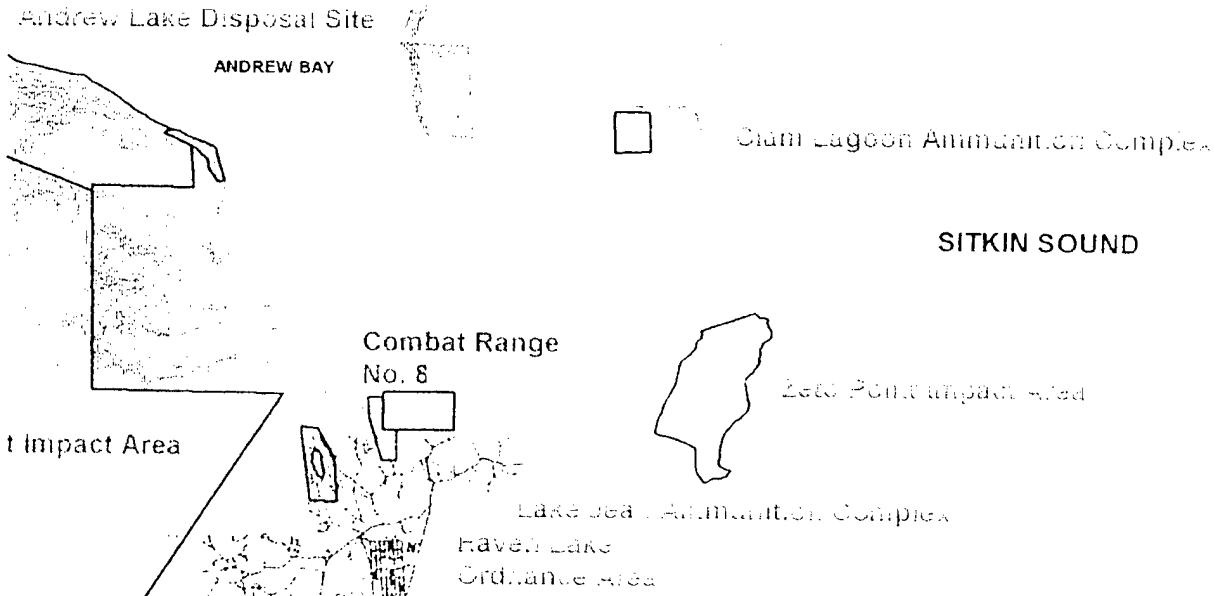
Figure 3. Expanded topographic map of Adak Island showing several of the areas of concern near Lake Andrew.

We skirted a section of the south and western edges of this site, walking about 0.4 miles overland. See Figure 3. The grass mat is 0.5-1.5 feet thick, the surface is varied, the highly

weathered areas have extensive gullies and relatively steep ($>15^\circ$) slopes. The flatter areas are rolling with shallow slopes and small depressions. We observed extensive debris, including timbers, metal scrap and assorted abandoned junk randomly scattered on the surface. We estimate that *MTADS* could traverse 40-50% of the area, although it would be highly susceptible to bottoming out or becoming stuck on high center from dropping a wheel into hidden depressions. We observed no ordnance-related items at this site.
